CSIRO ACOUSTIC MEASUREMENT REPORT

Warehouse 4, 94-98 Kirkham Road West, Keysborough, Vic 3173

Measurement Type: Impact Sound Insulation (Floor)

Test Specimen (Area of concrete test floor: 10.8 m² [3.6 x 3.0 m])

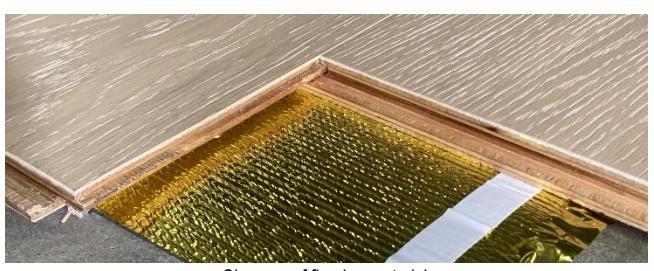
Close-up of flooring materials

Description: • Sunstar 'Oak Classic' 12 mm engineered timber flooring planks · on Sunstar 3 mm EVA underlay · resting on a 150 mm thick concrete subfloor.

- a] Sunstar 'Oak Classic' engineered timber planks: Stock code: HW012-12 & HW012-NEW-12 ('Hastings')
- 12 mm engineered European oak planks, inc 1.2 mm veneer
- Dimensions: 1900 x 190 mm (approx 30% nested)
- With interlocking edge profiles (Sunstar drop-lock system)
- Mass per unit area: 7.8 kg/m² (meas)
- b] Sunstar 3 mm EVA foam underlay, with gold-coloured moisture barrier film; supplied on a roll (1100 mm width, plus 90 mm selvedge), 346 gsm (meas).
- c] Concrete slab subfloor (of the laboratory), 150 mm thick, 360 kg/m² approx.

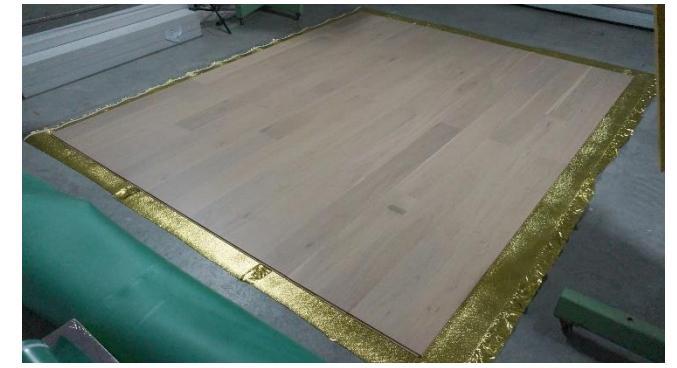
Test specimen installed in laboratory for test

- The concrete subfloor [item c] was swept in preparation for flooring installation.
- · Underlay [item b] was cut to length and laid {foil up) on the concrete subfloor. 3 pieces of underlay were joined together using the selvedge and pre-applied pressure sensitive tape, covering the entire area of the concrete subfloor (excess allowed to overhang), resting on the surrounding floor. The underlay was not adhered to the concrete subfloor.
- Flooring planks [item a] were laid on top of the underlay (no adhesive) secured together via their interlocking edge profiles. A combination of full and part-length planks was used to fully cover the concrete subfloor with plank joins staggered from row to row. Excess flooring was allowed to overhang and rest on the surrounding floor of the chamber, level with the test-floor
- Installation was carried out by laboratory staff.
